Statistical Correlation of Observed
Ground Motion with Low-Rise
Building Damage: Project Rulison,
January 1973

Statistical Correlation of Observed Ground Motion with Low-Rise Building Component Damage : Project RULISON

by
R. E. Scholl
and
I. Farhoomand

John A. Blume & Associates
Research Division
San Francisco, California

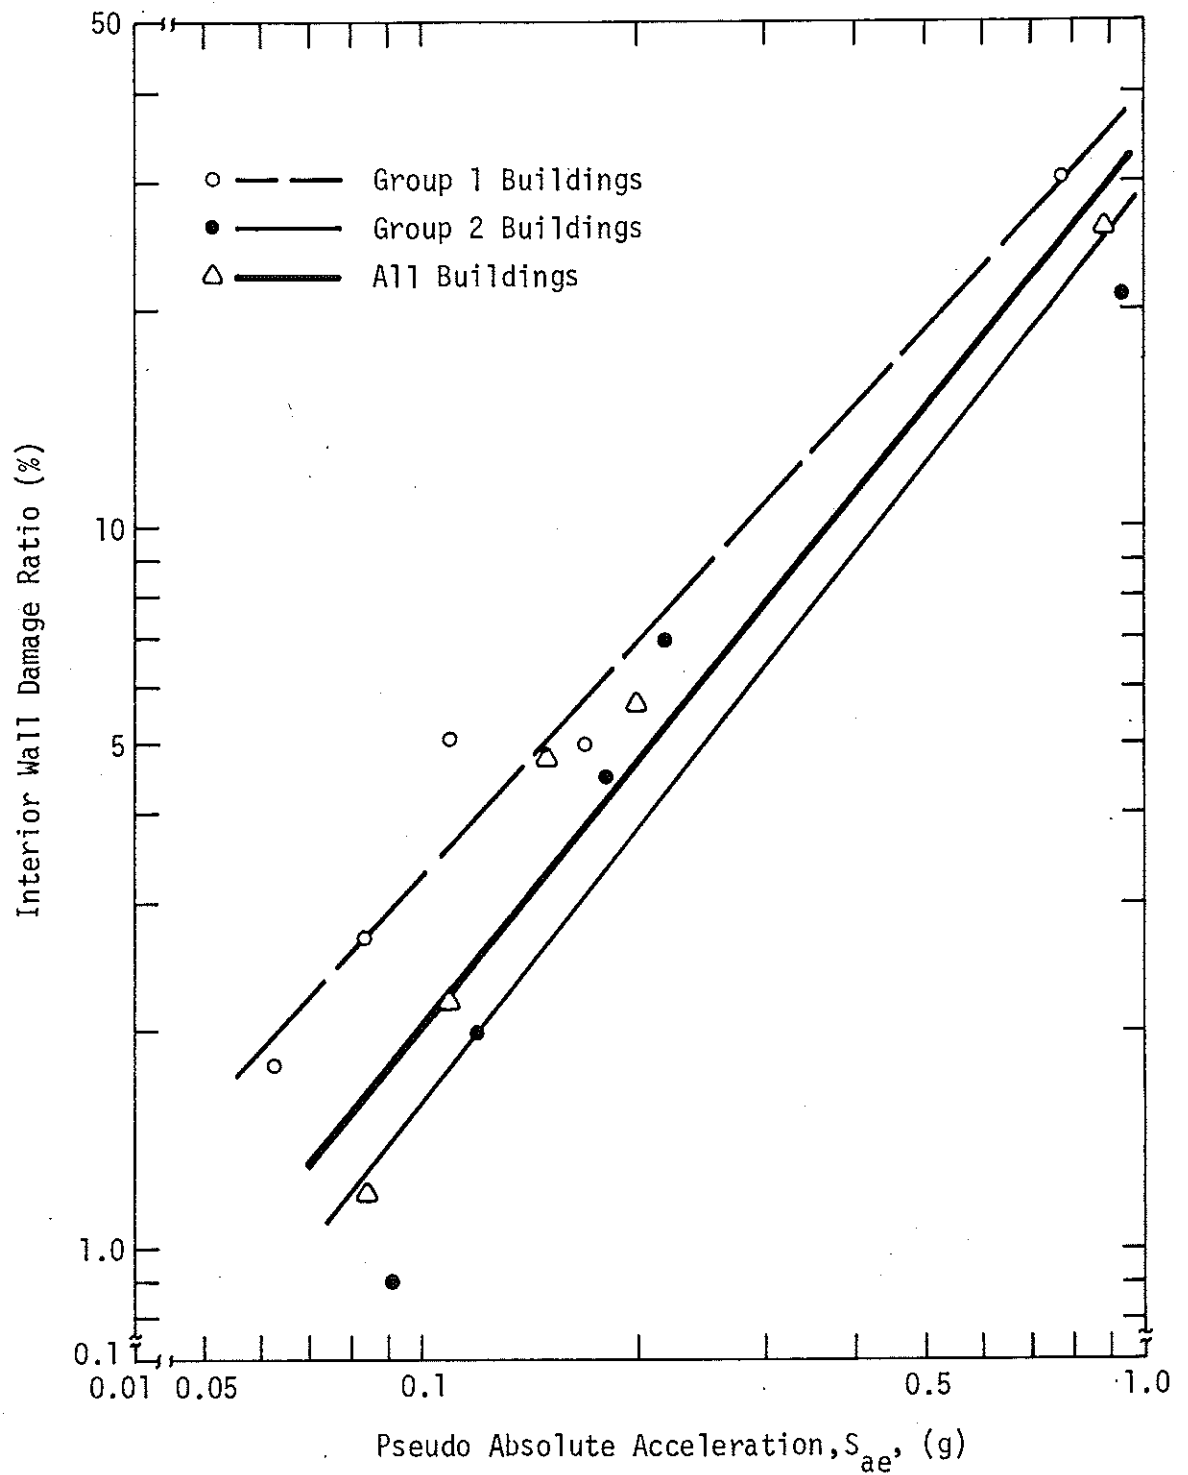
FIGURE 17 DAMAGE RATIO FOR INTERIOR WALLS
(BY BUILDING GROUP) VS SPECTRAL INTENSITY

Table 6 presents the damage ratios of interior walls for the various building groups in the five towns. The plots of damage ratio for walls in masonry and wood-frame buildings (Figure 16) indicate that interior walls in masonry buildings are more susceptible to damage than interior walls in wood-frame buildings, although the difference decreases as the spectral intensity increases. Figure 17 shows the variation of damage ratio of interior walls for the two building groups with spectral intensity S_{ae} . These two figures suggest that the interior walls of the masonry buildings and Group 2 buildings have the lowest and the highest damage thresholds, respectively.

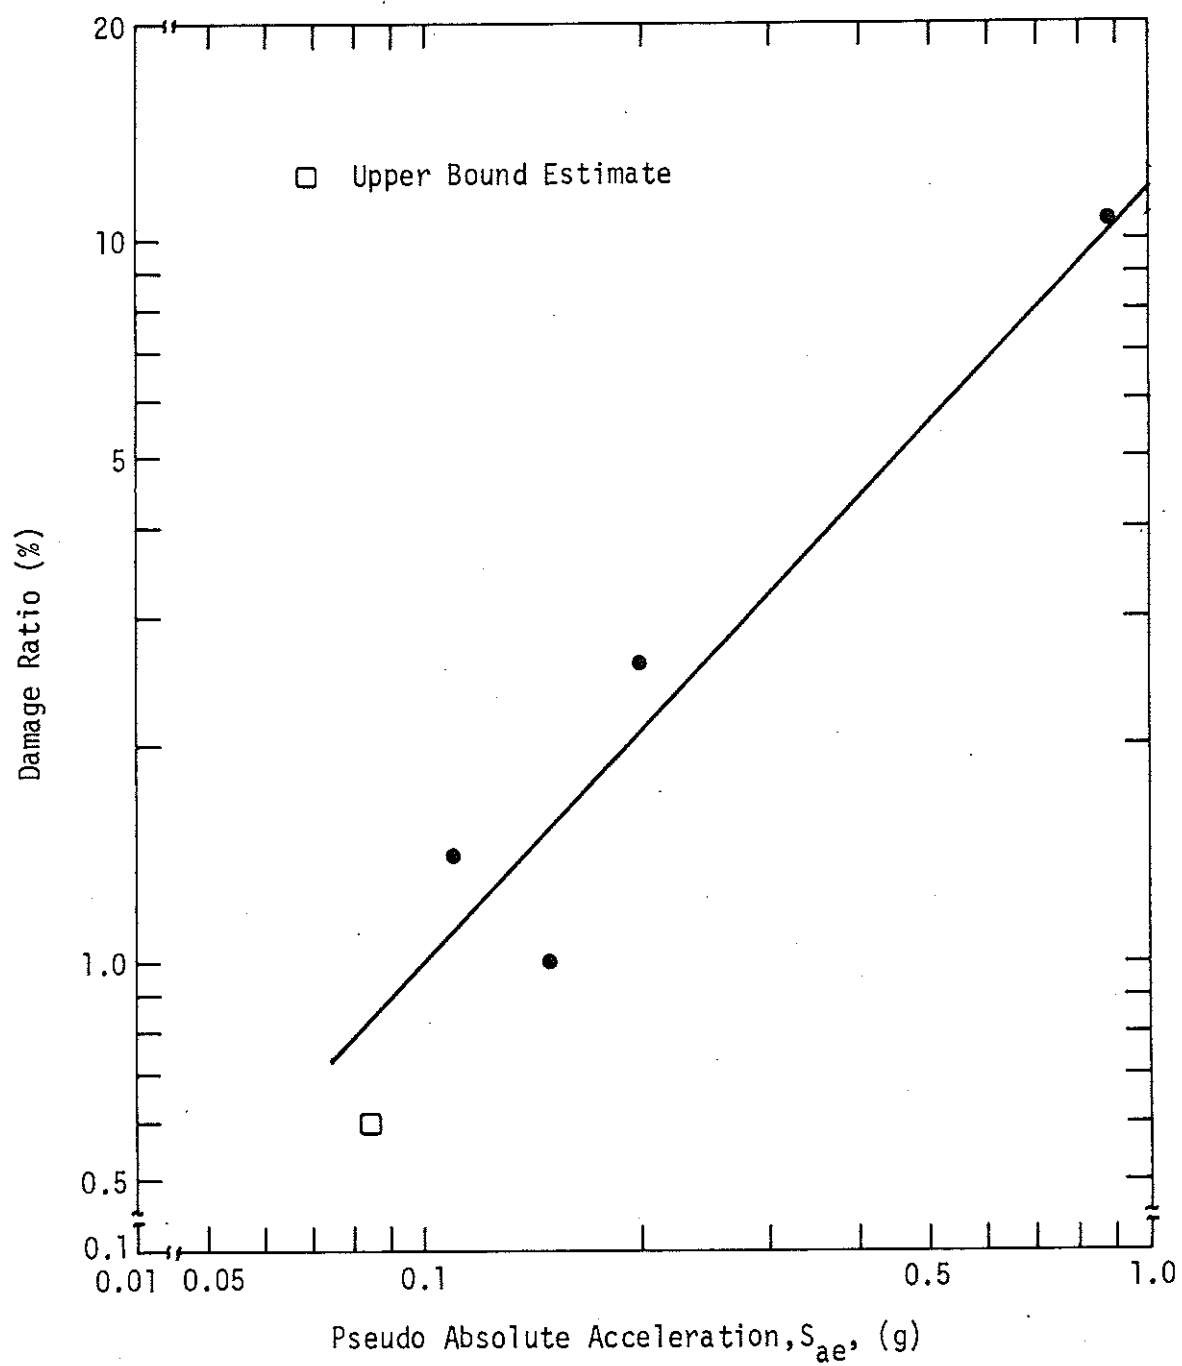
FIGURE 19 DAMAGE RATIO FOR FOUNDATIONS
VS SPECTRAL INTENSITY

Damage ratios for foundations plotted against spectral intensity are given in Figure 19. The figure shows that foundation damage is not serious for the range of spectral intensity included in this investigation.
